## Site Inspection Report Summary

**Property Address:** 6231 PA-88 Finleyville, PA 15332

**Inspection Date:** 06/10/2020

## **Photo Report of Koteles Garage**

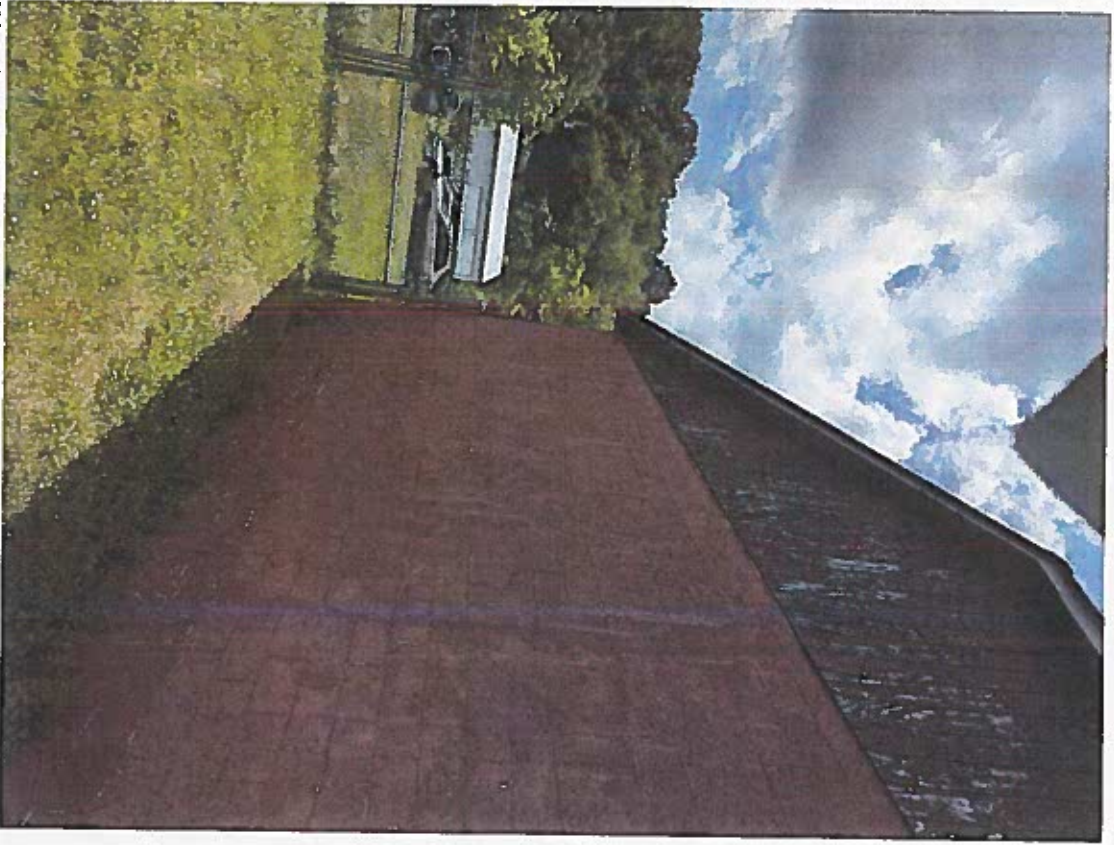
Wooden roof panels are in need of painting.

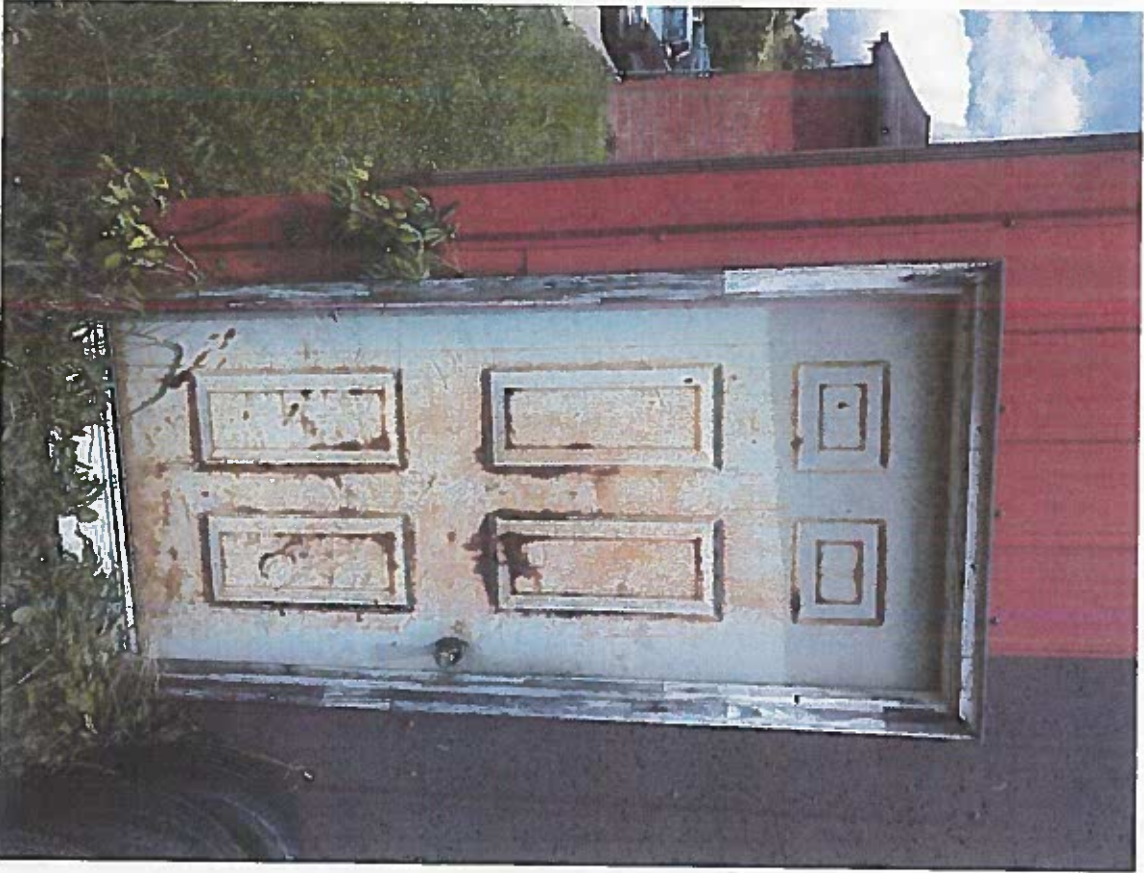
Rusty door, unpainted trim, plants growing under trim.

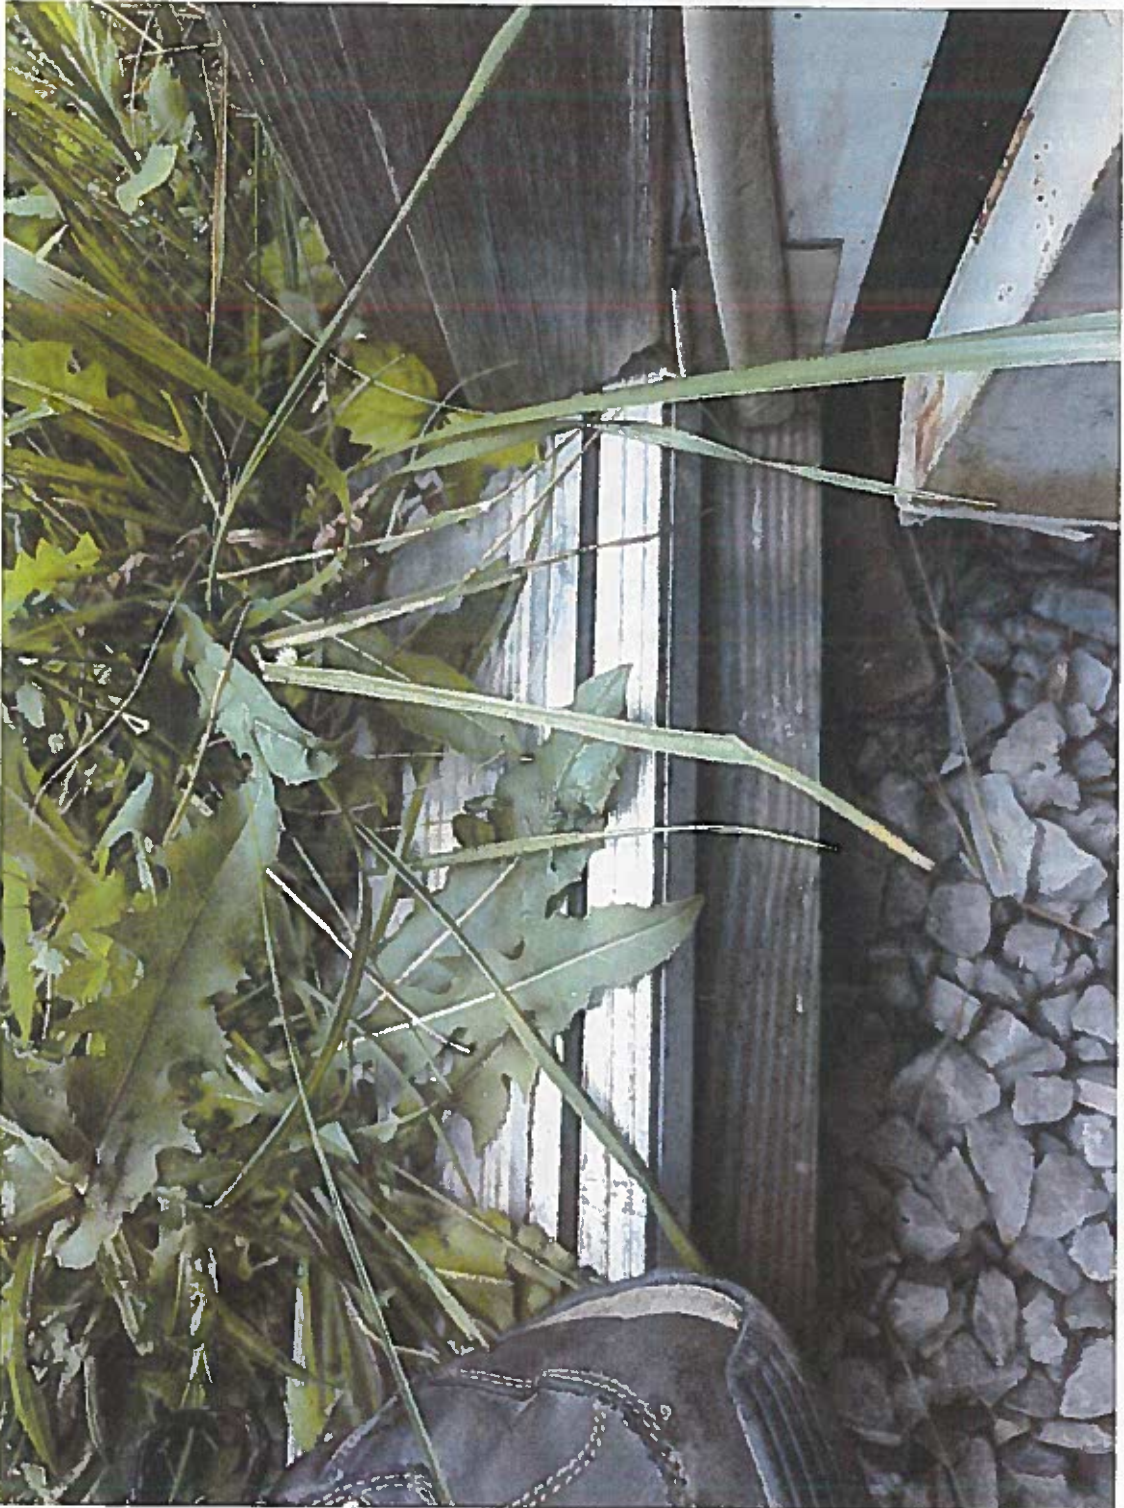
Damaged lower door plate view #1

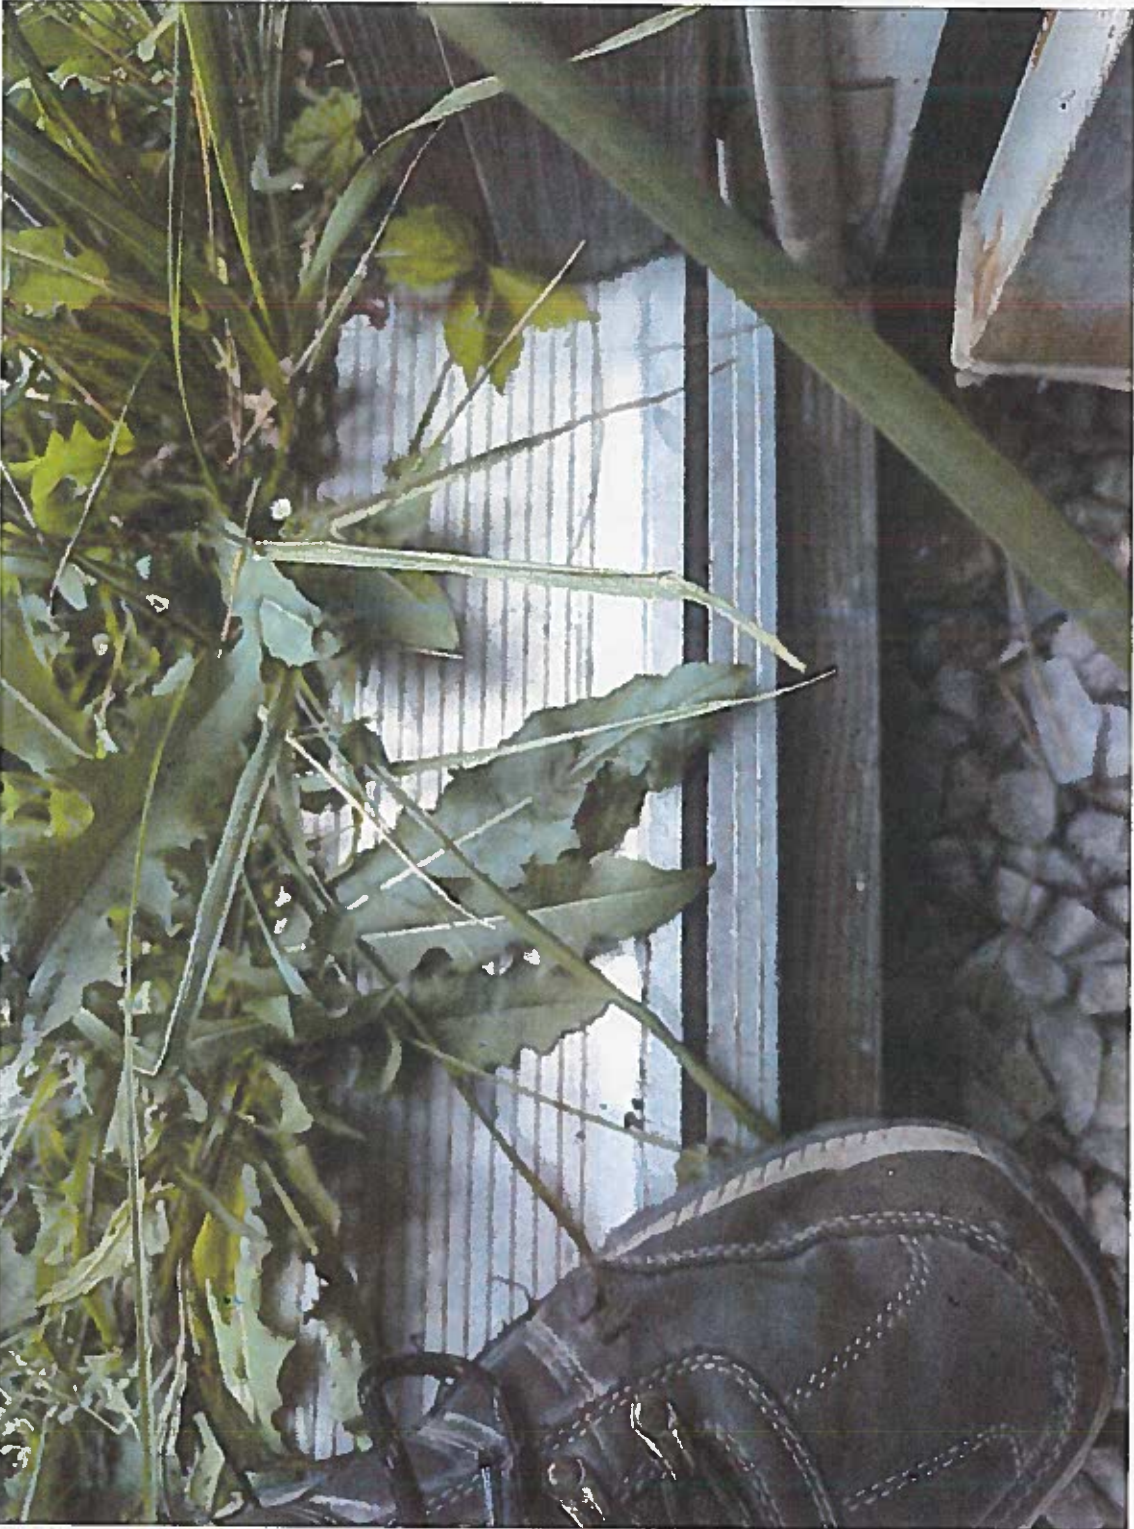
Damaged lower door plate view #2

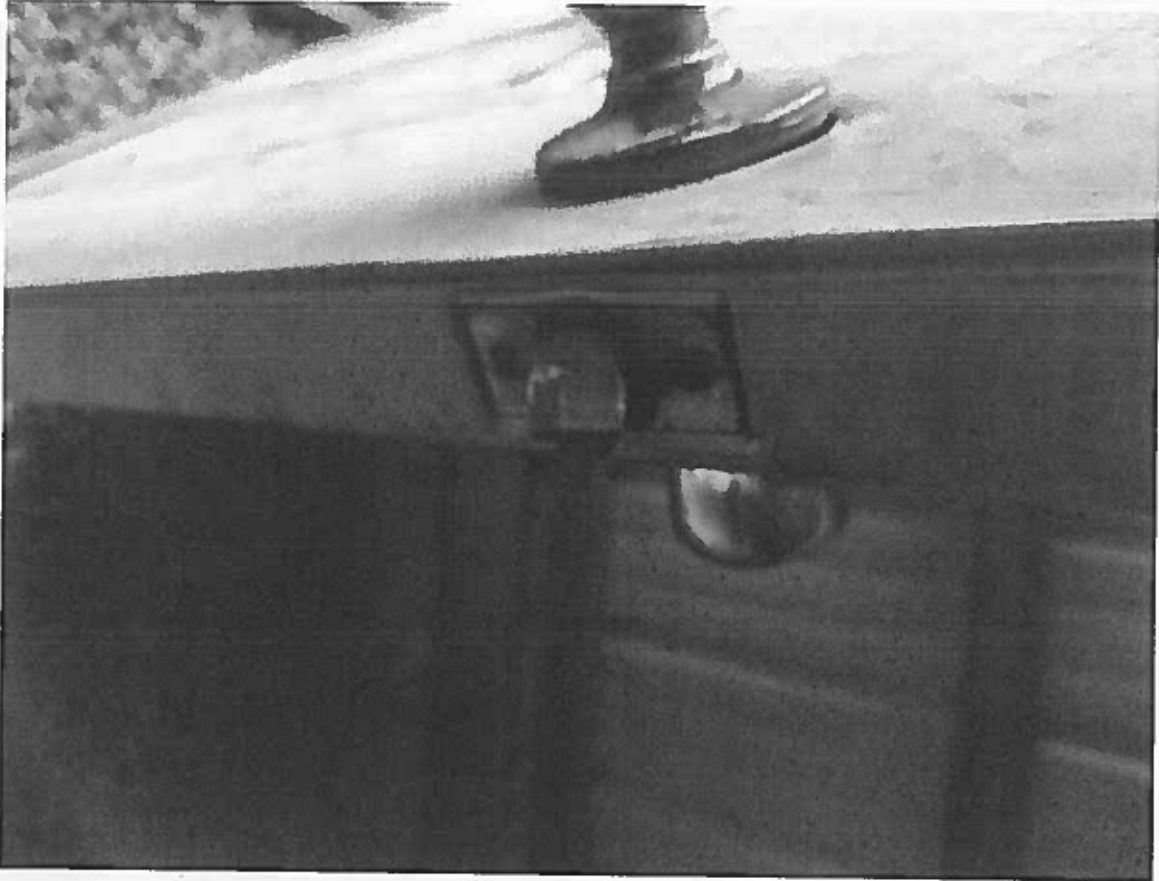
Door striker plate damage

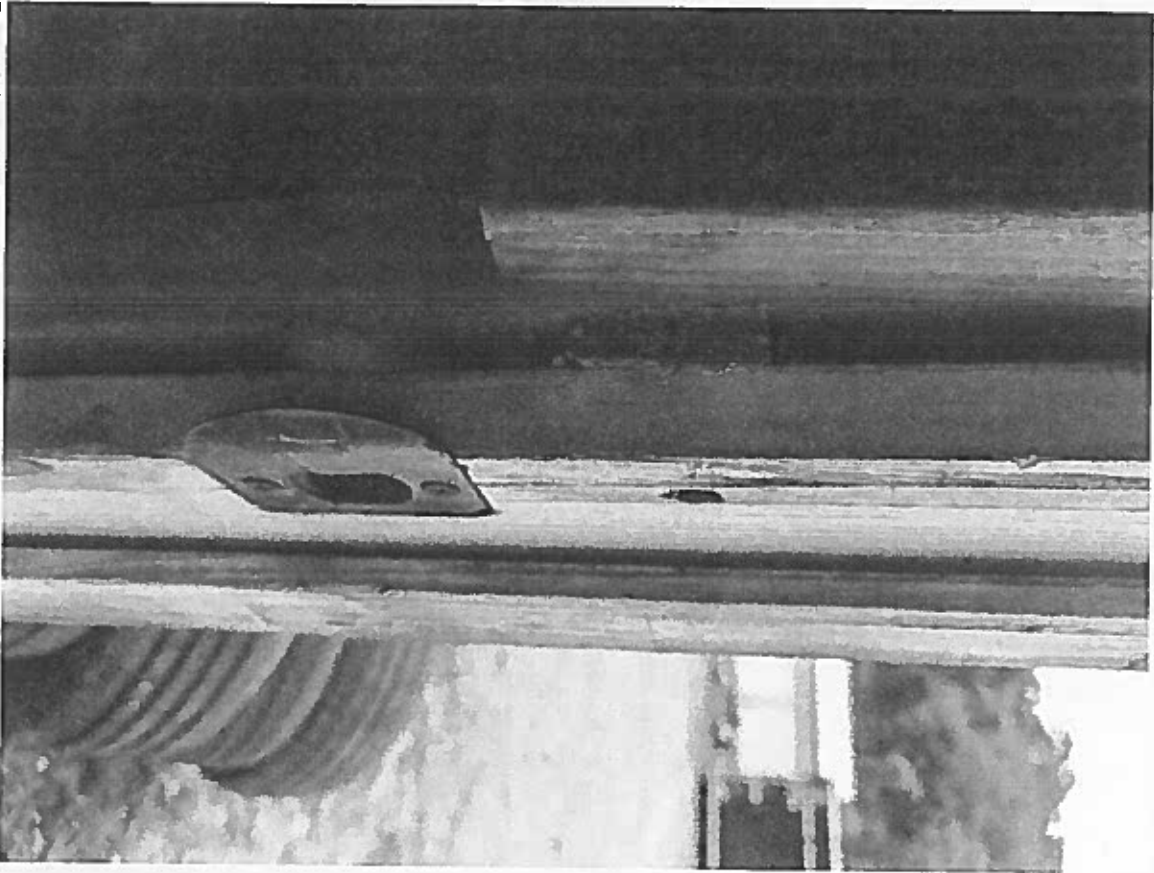
Bent / damaged wood around door frame.

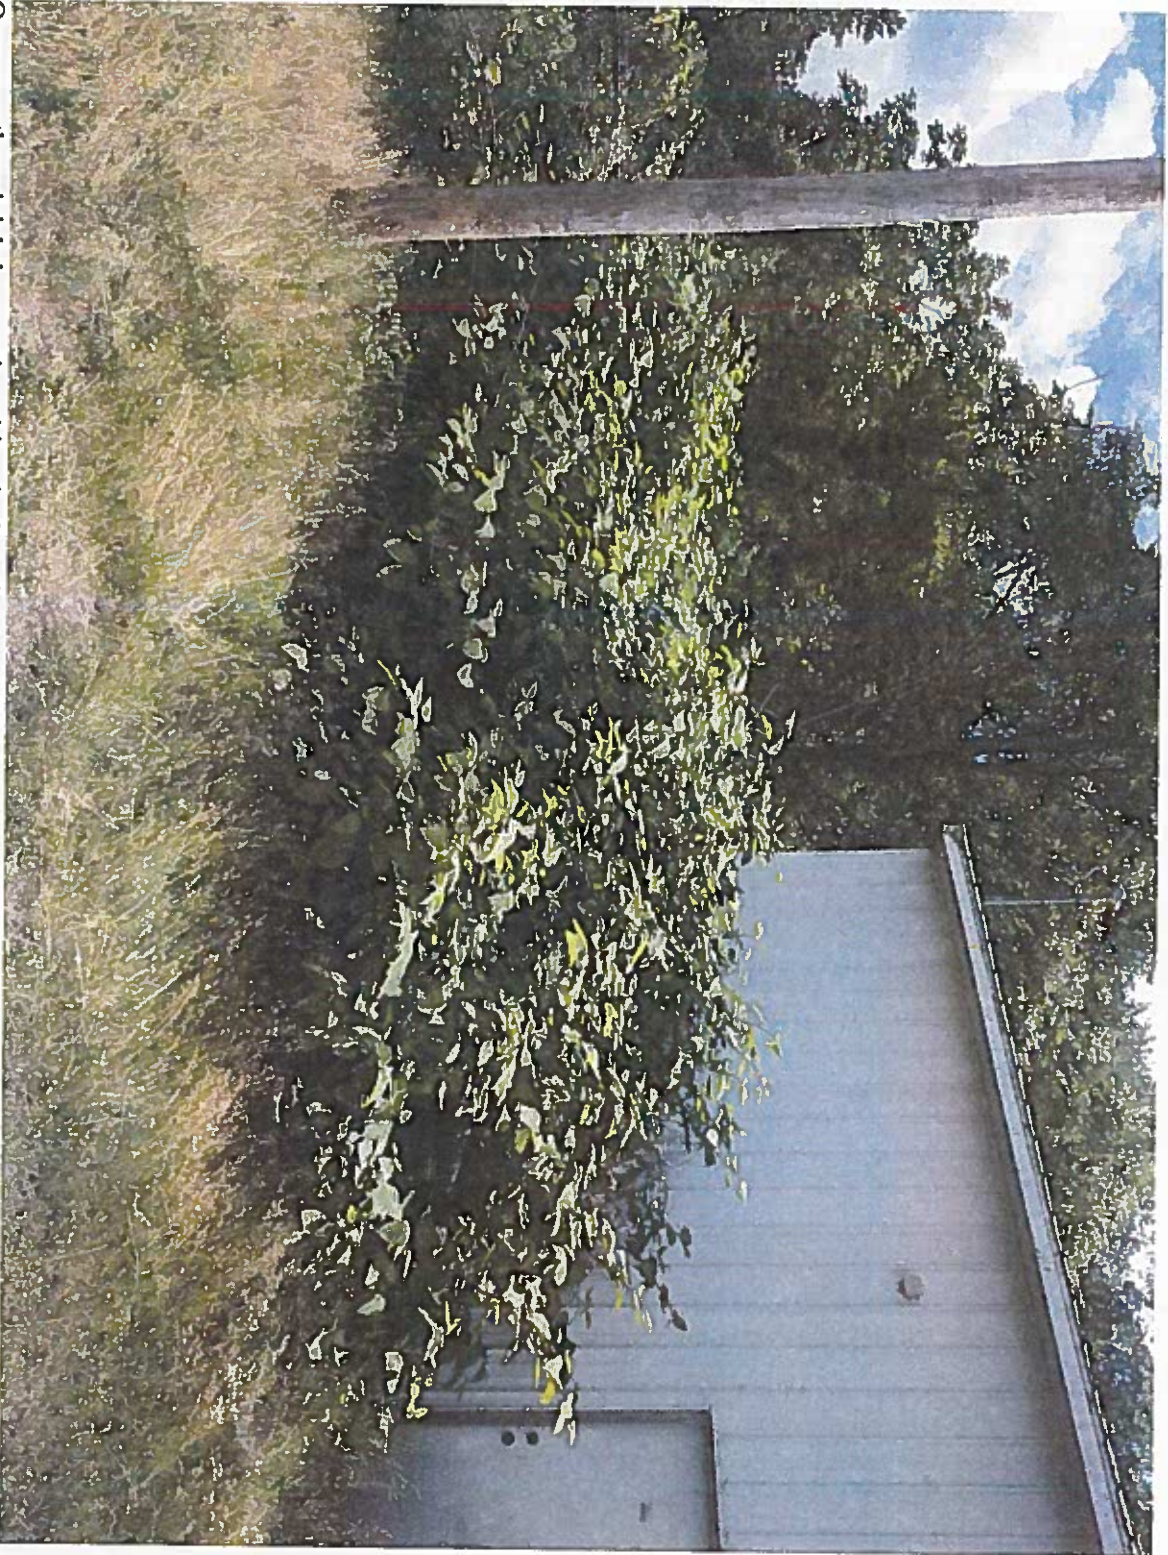
Overgrowth and debris near the white shed on the rear of the property.

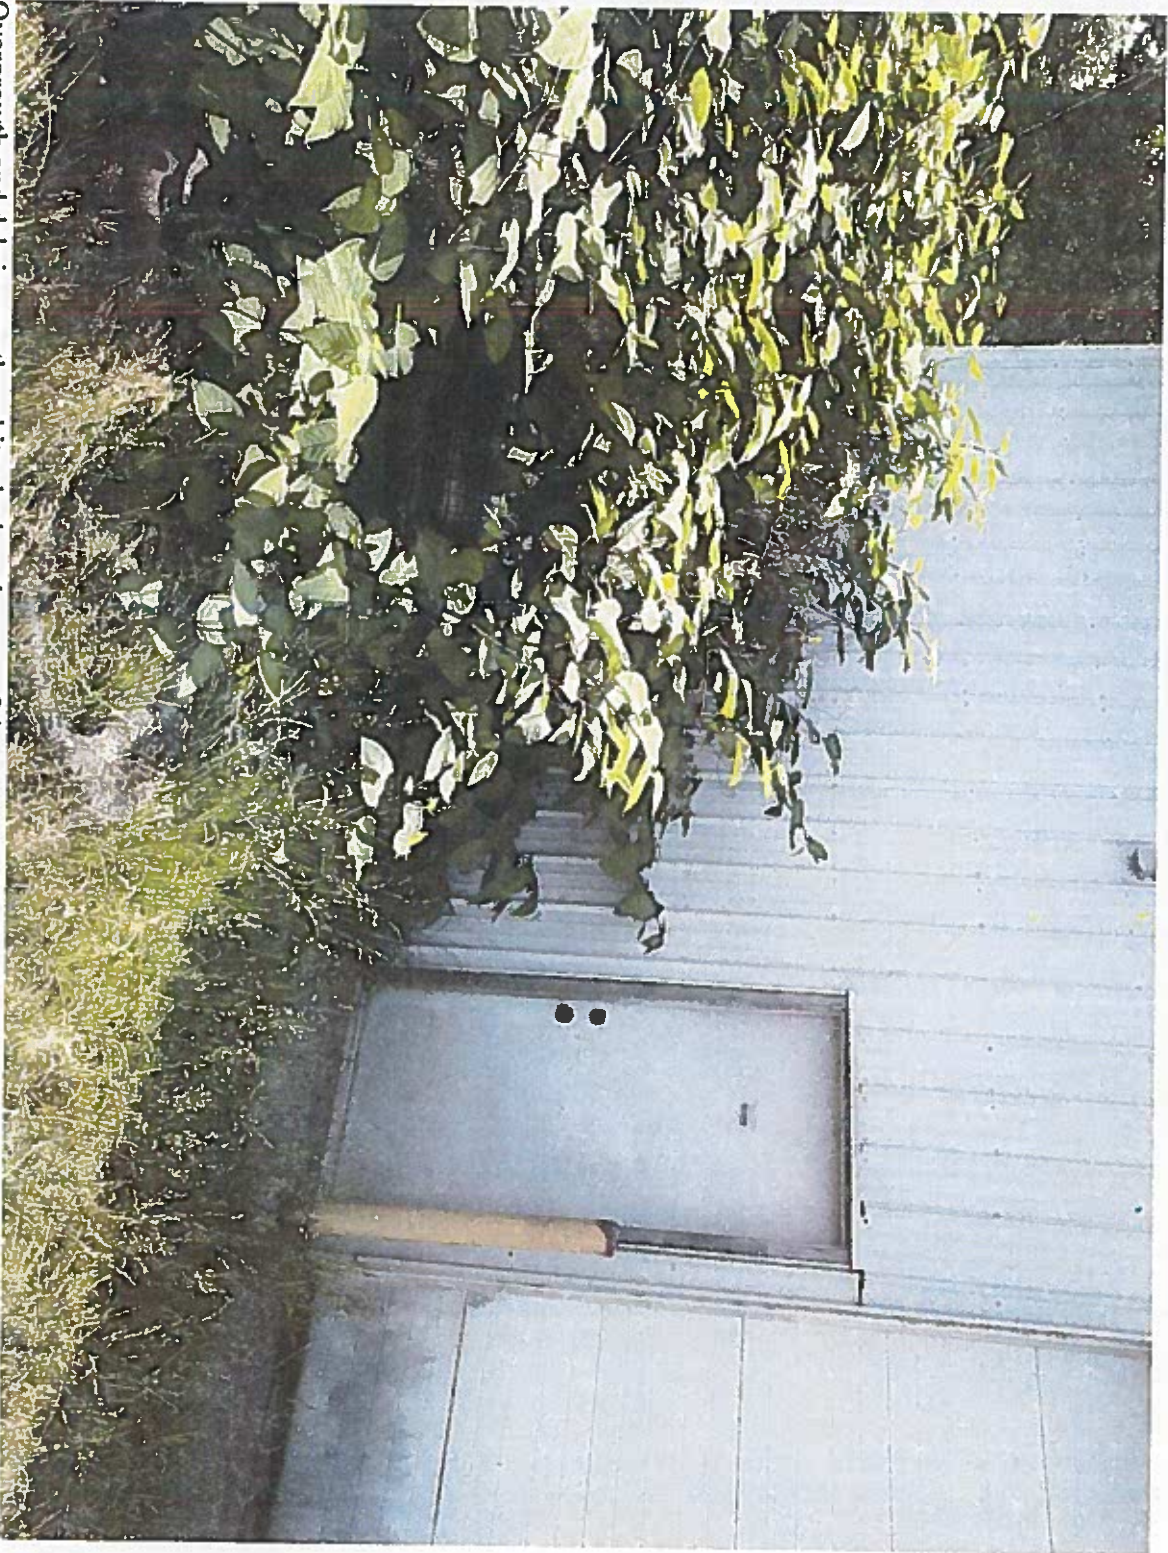
Overgrowth and debris near the white shed on the rear of the property. Notice the rear door condition.

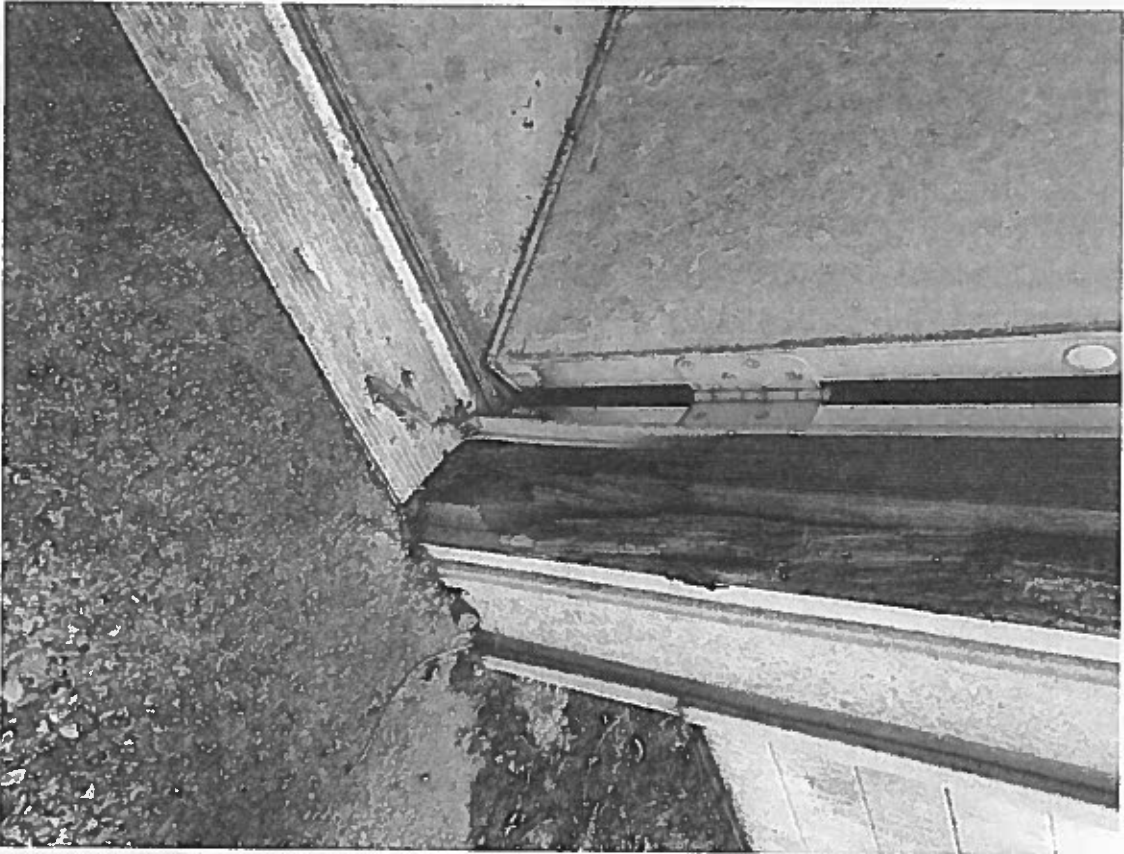
Rotting wood located around rear wooden door.

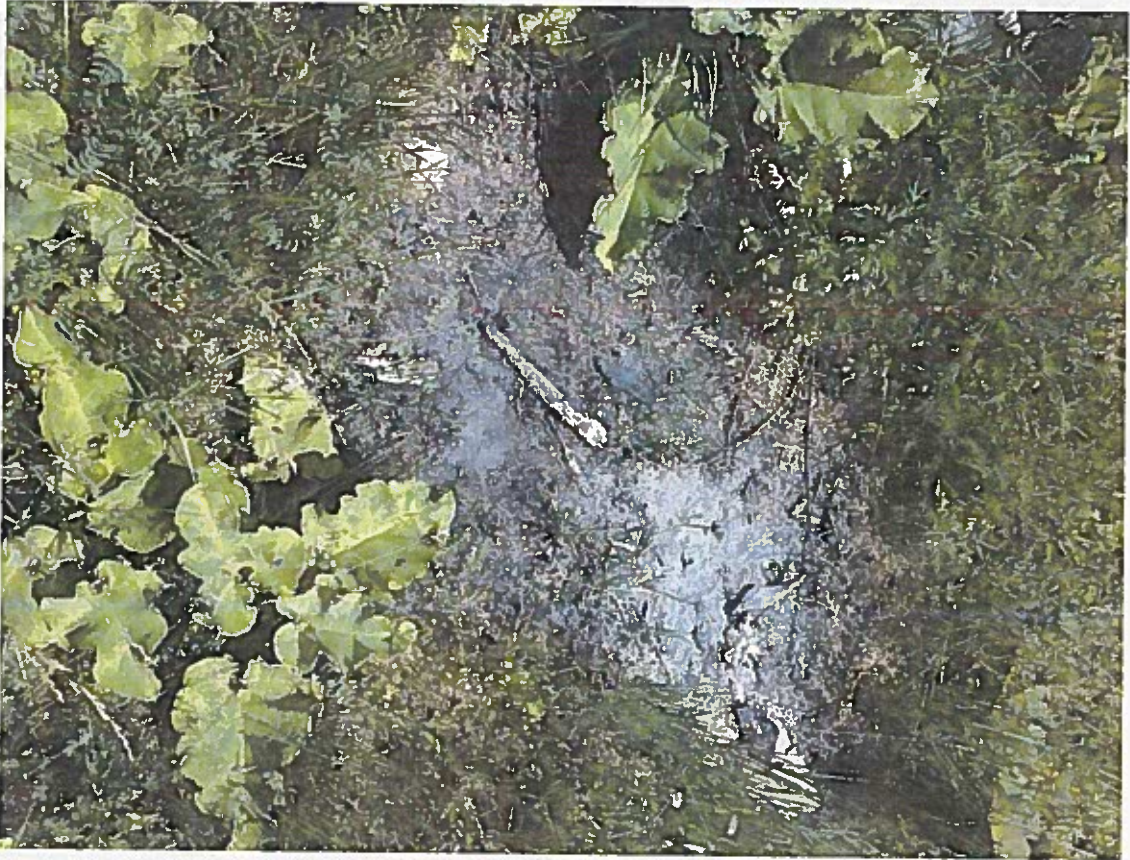
Large burn mark in the ground adjacent to the rear white shed.

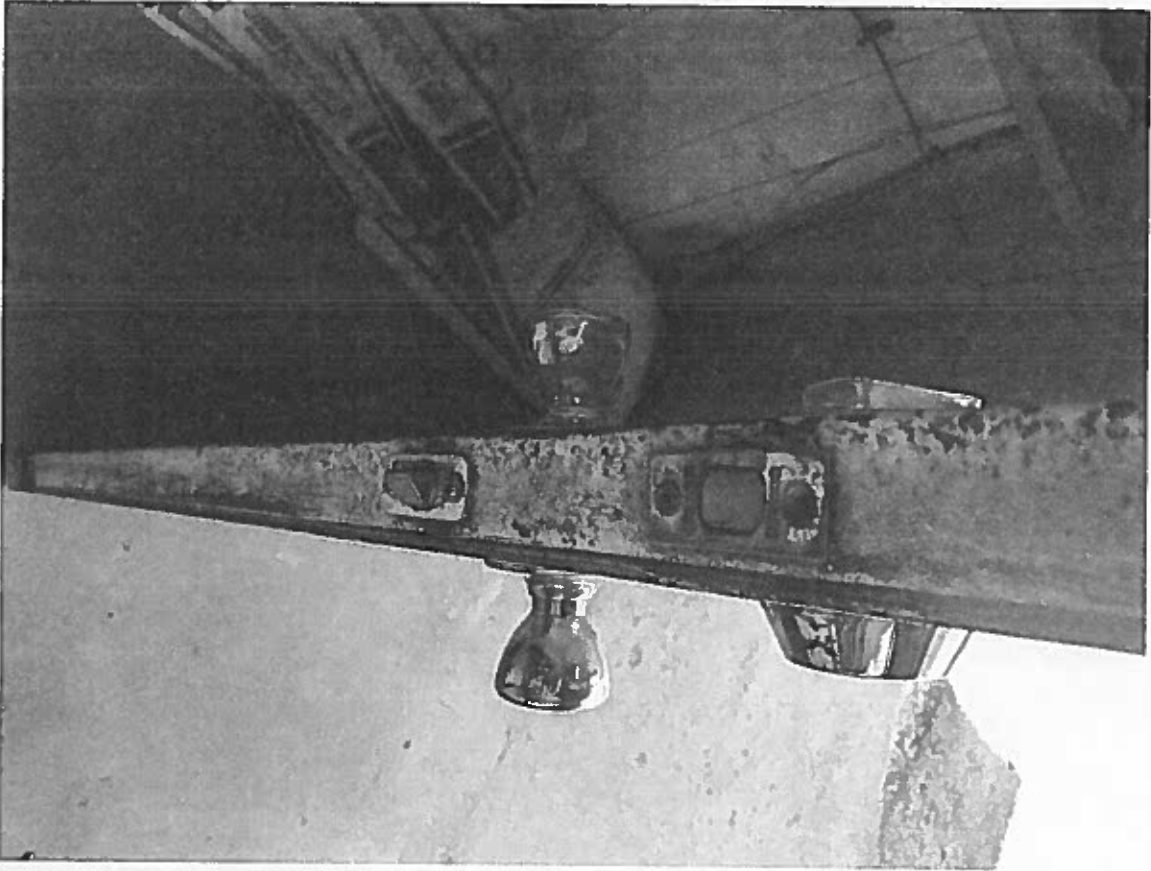
Extensive wear and tear on front entry door for customers. Rusty, needs repainted, damaged striker plate.

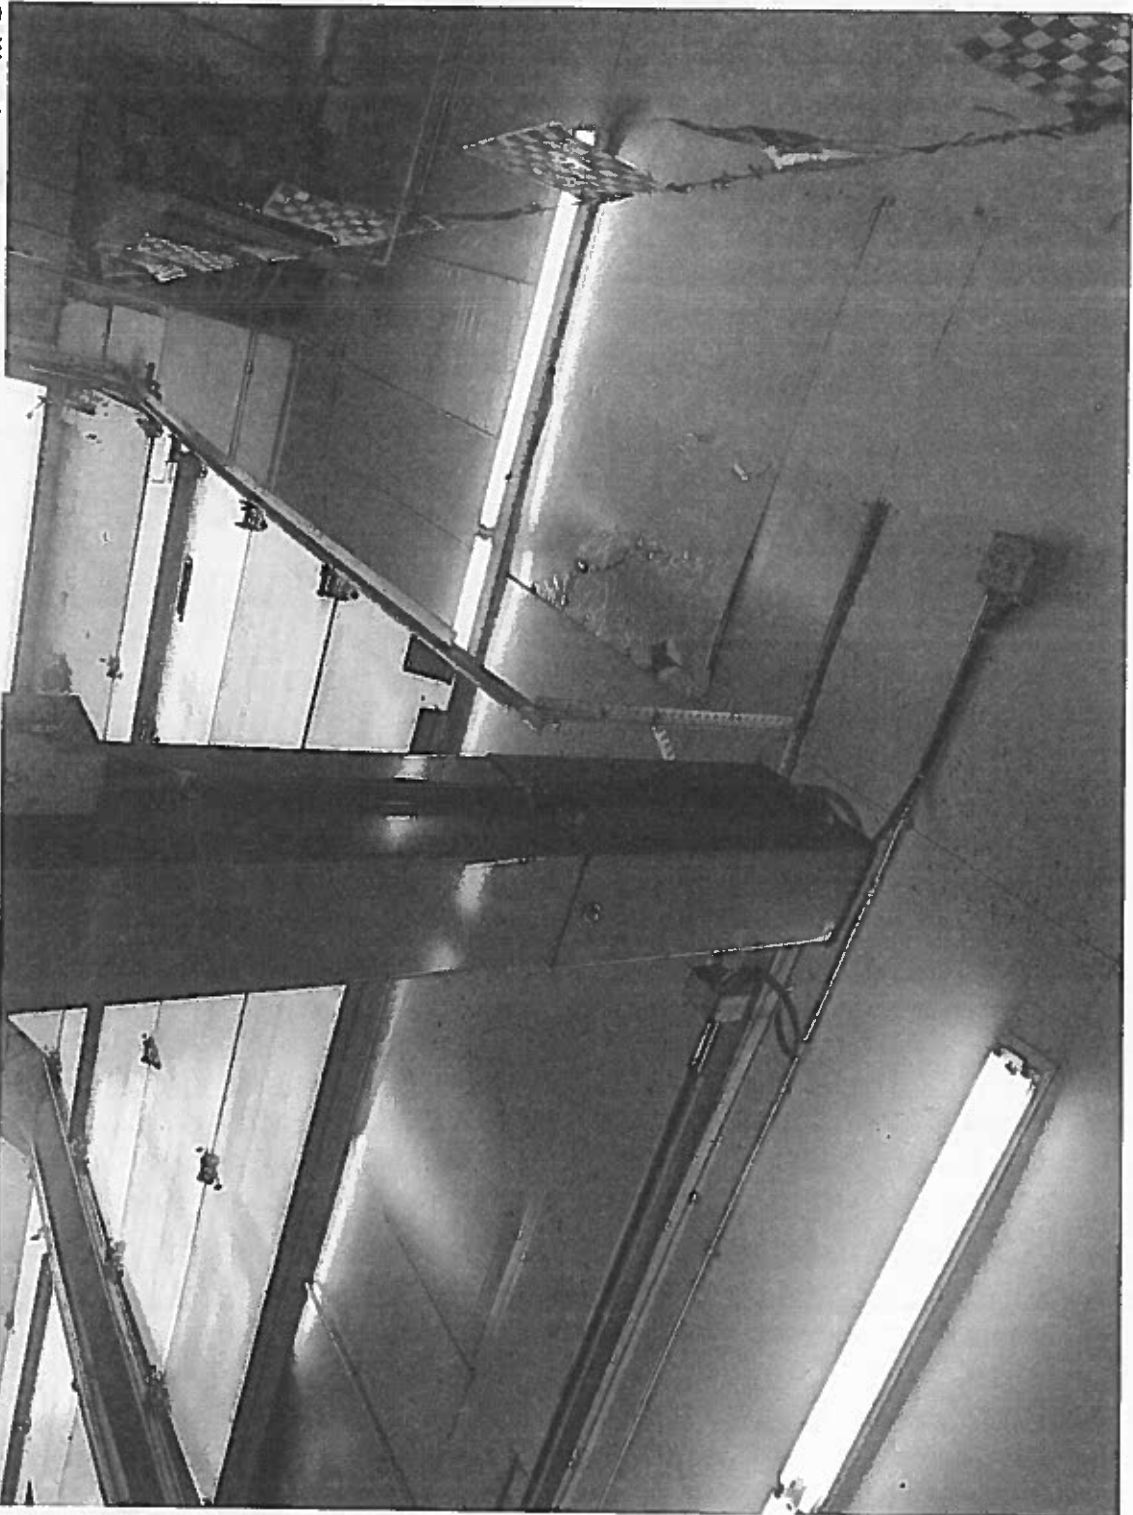
Ceiling damage in main bay area.

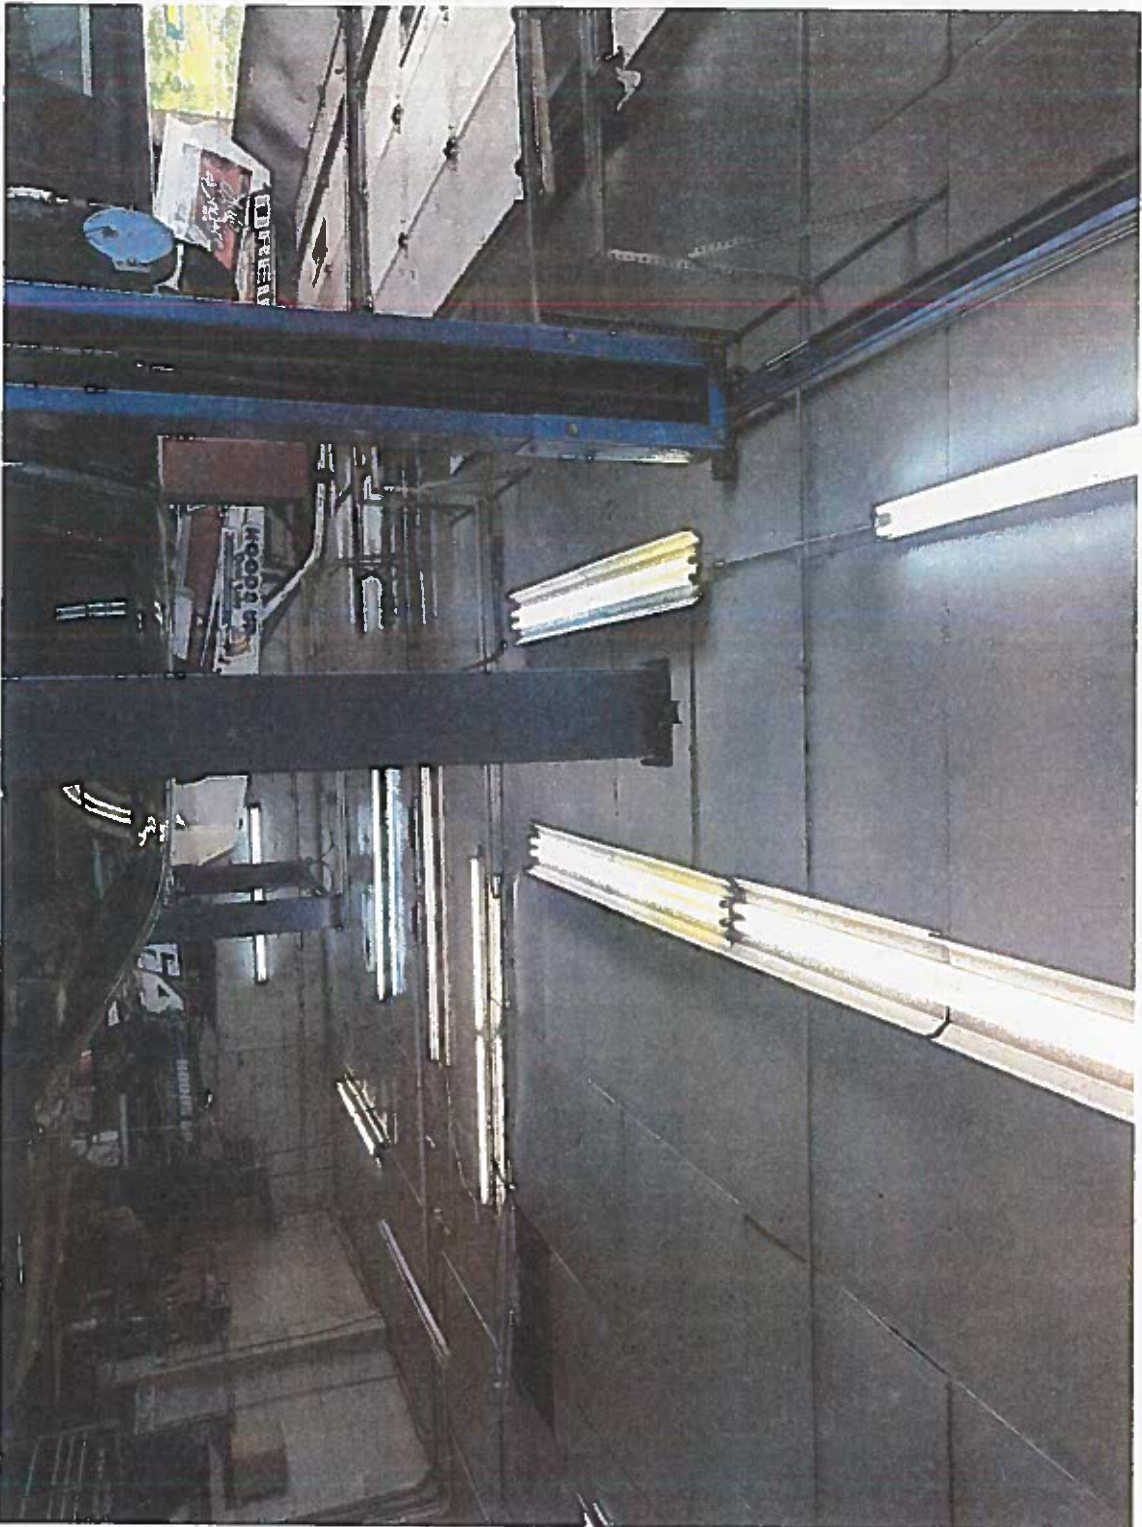
Ceiling damage in main bay area.

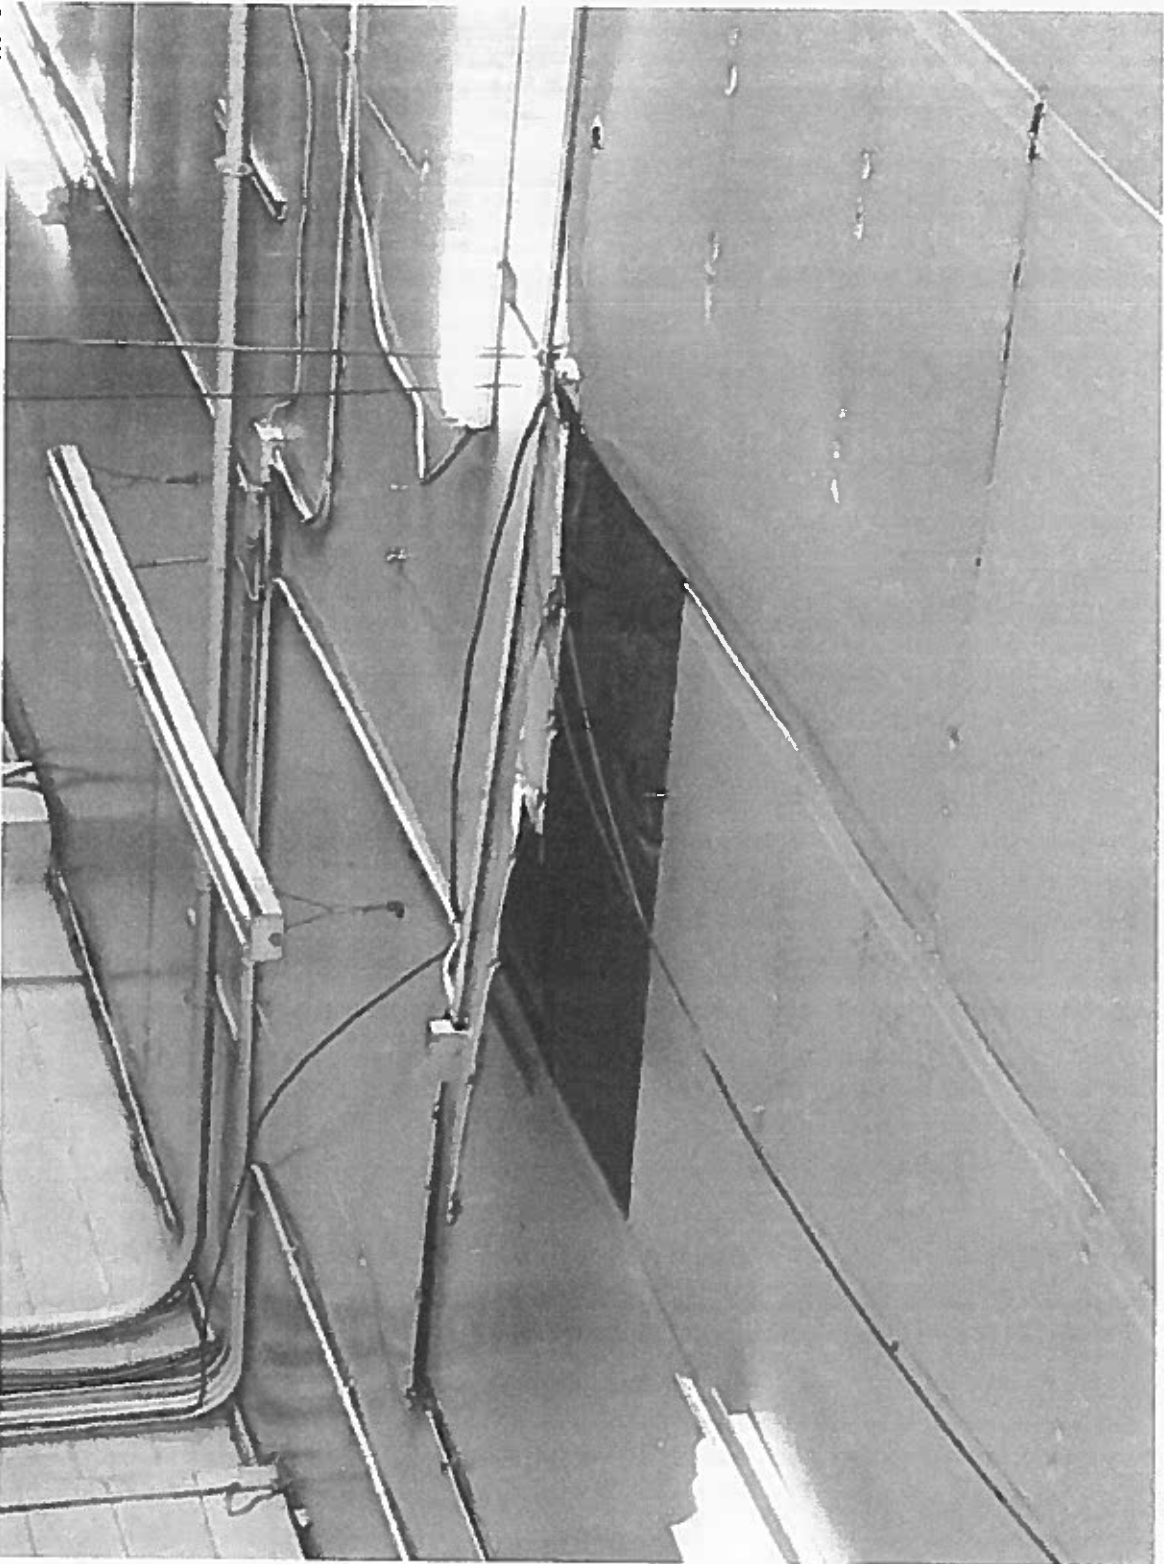
Ceiling damage in main bay area.

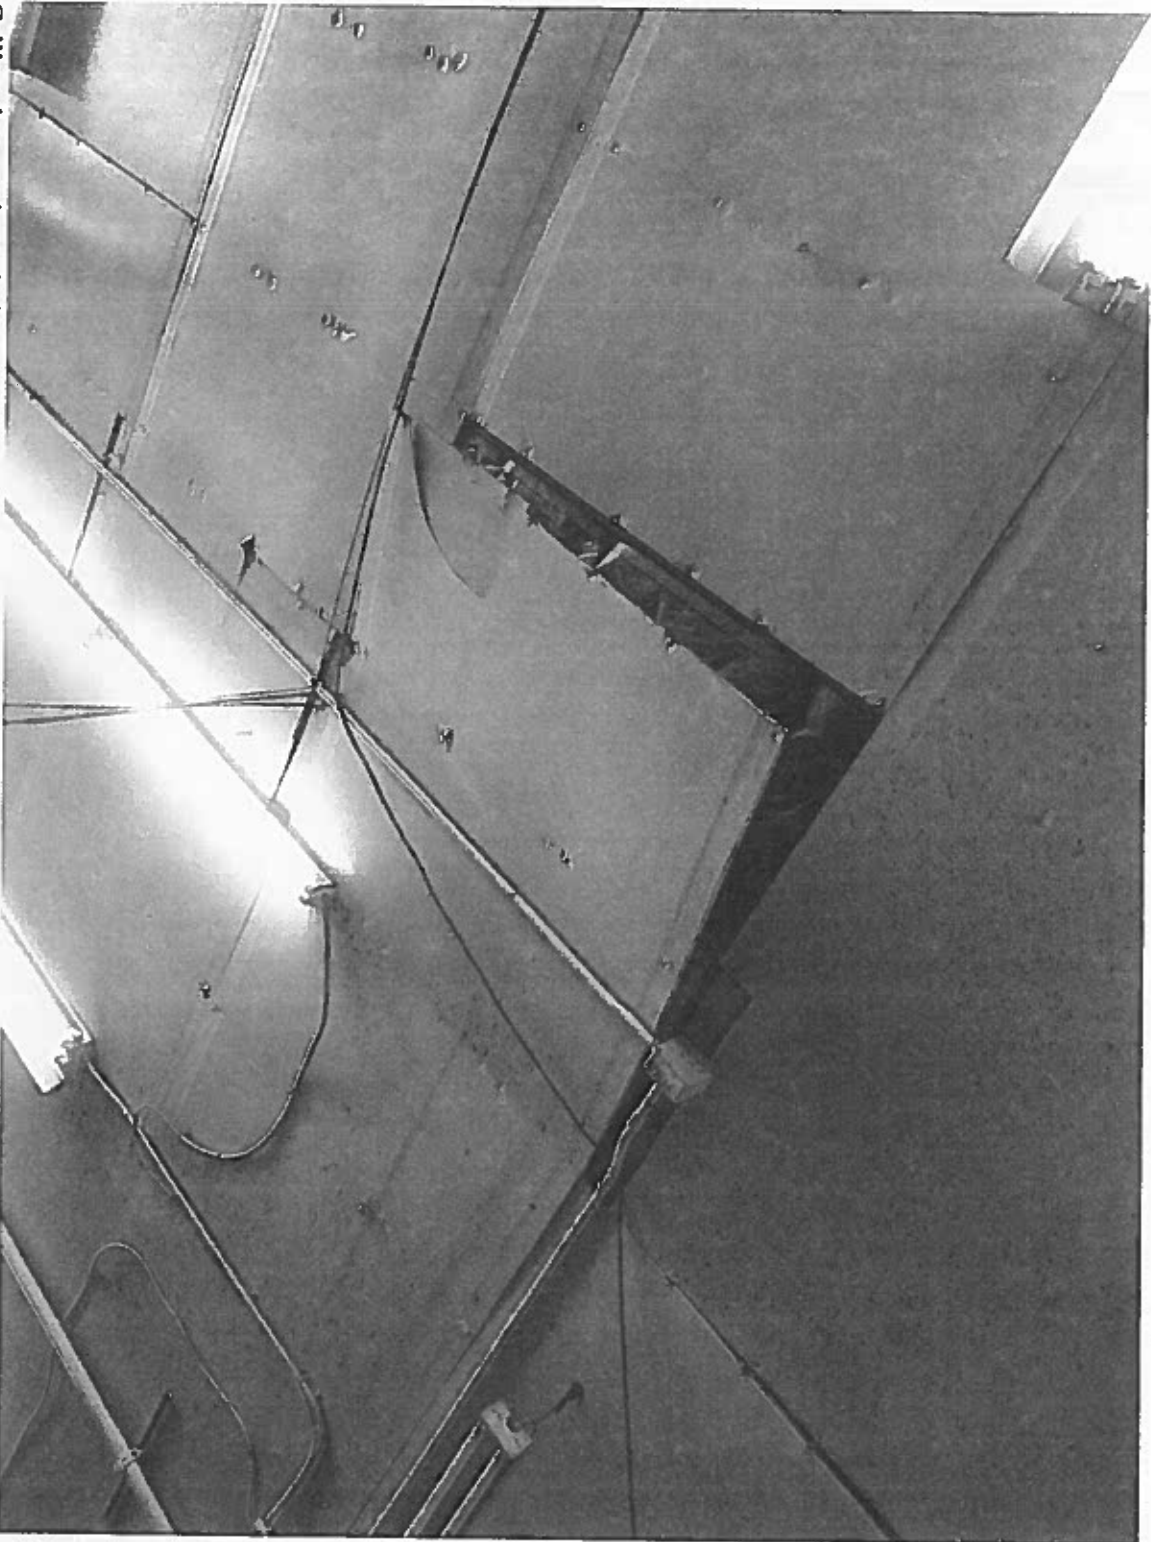
Ceiling damage in main bay area.

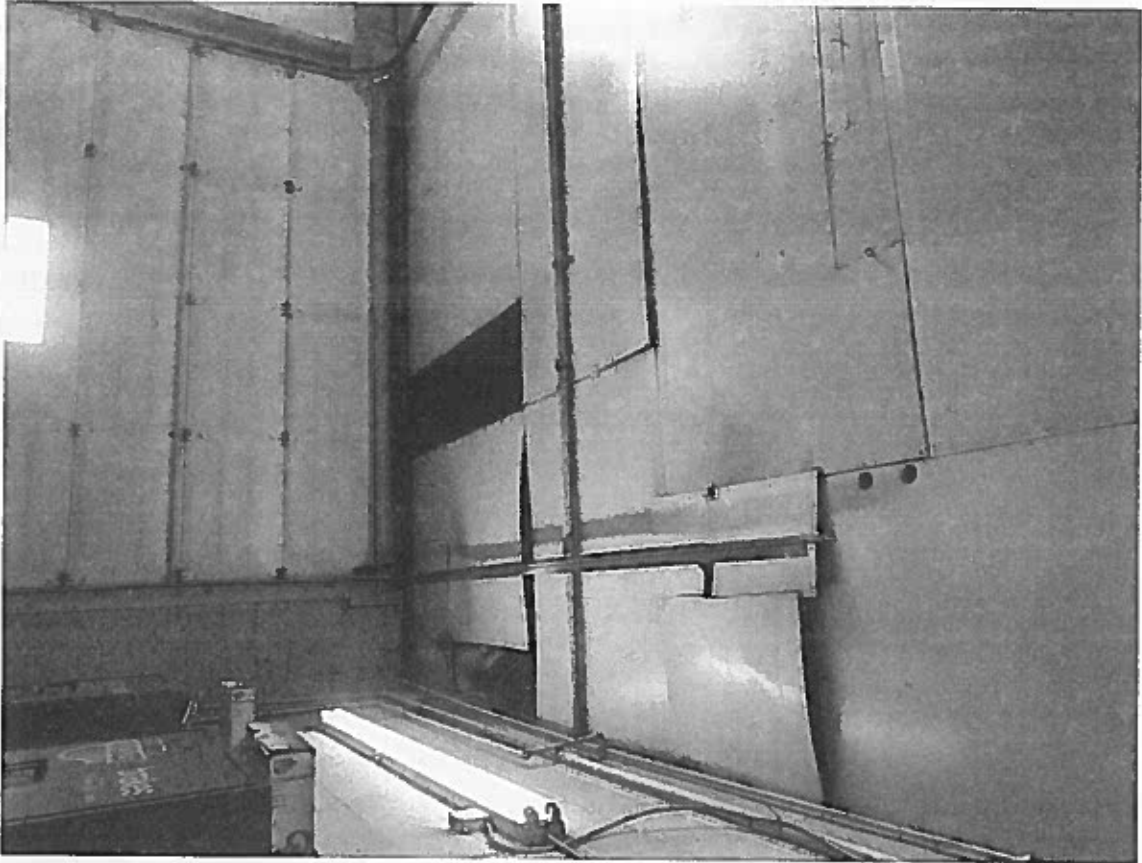
Ceiling damage in main bay area.
